CANON USA
EYE CARE SOLUTIONS

Fundus Autofluorescence
Take the Test

What is Fundus Autofluorescence?

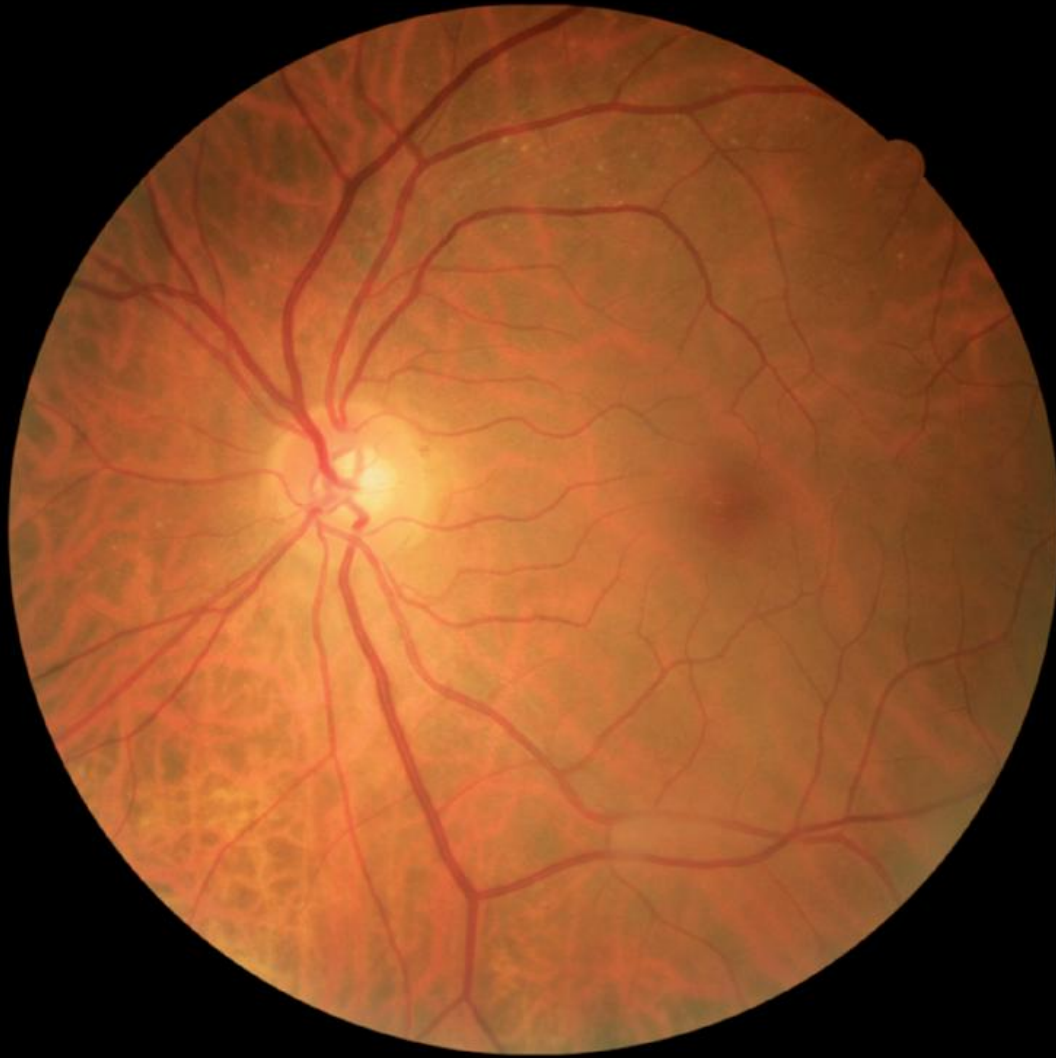
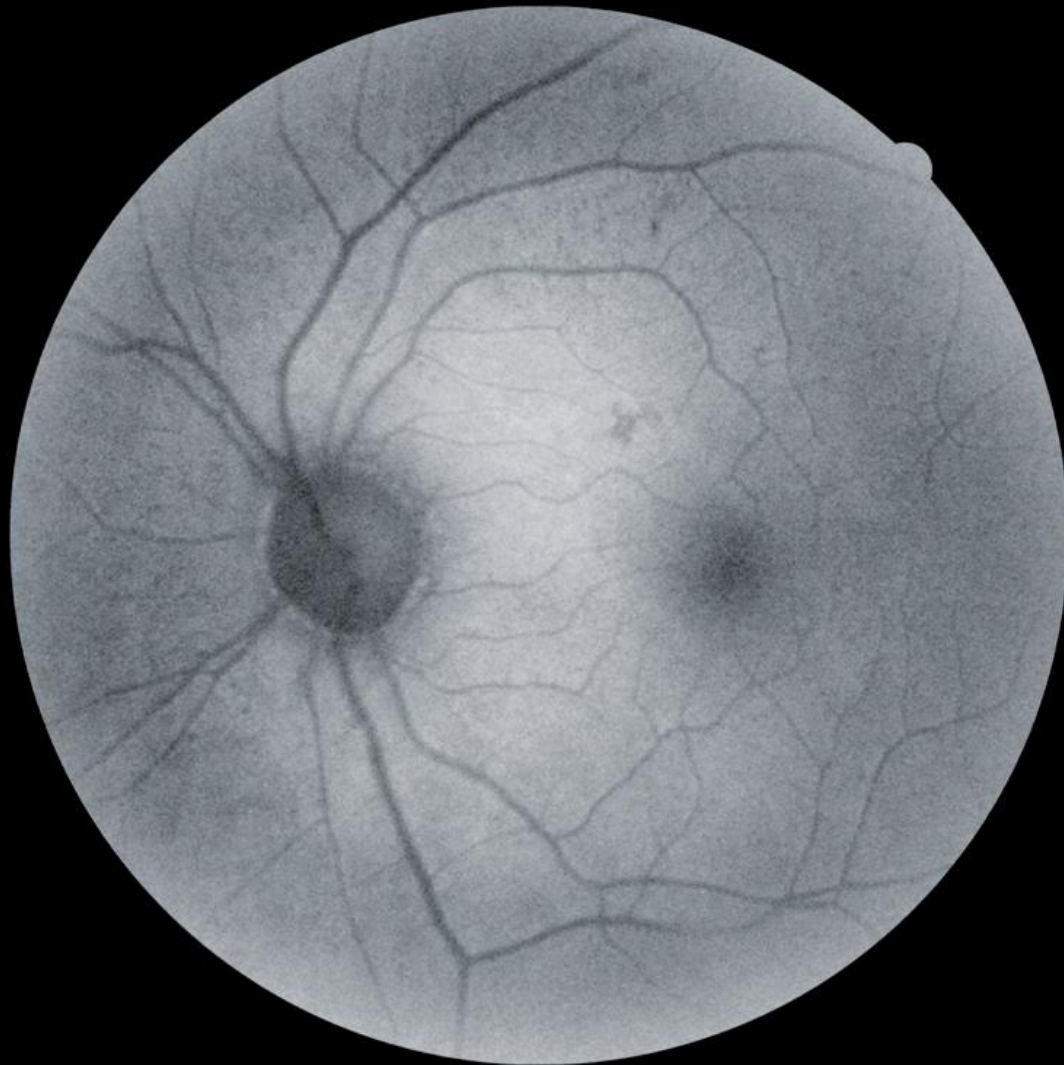
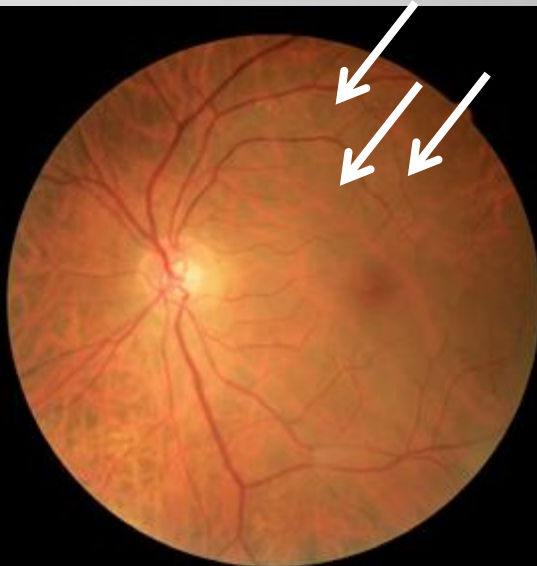
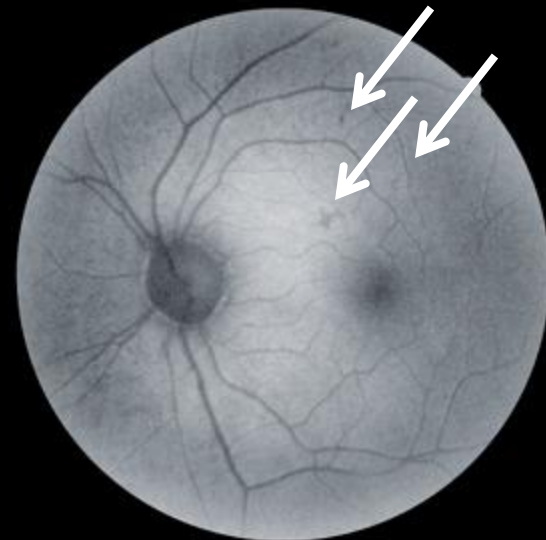
Case #1

- The colored image shows presence of a few hard drusen superior to the macula and in the fovea.
- The FAF shows some dark spots indicating minor RPE damage which are only partly correlated to the drusen seen in the colored image.

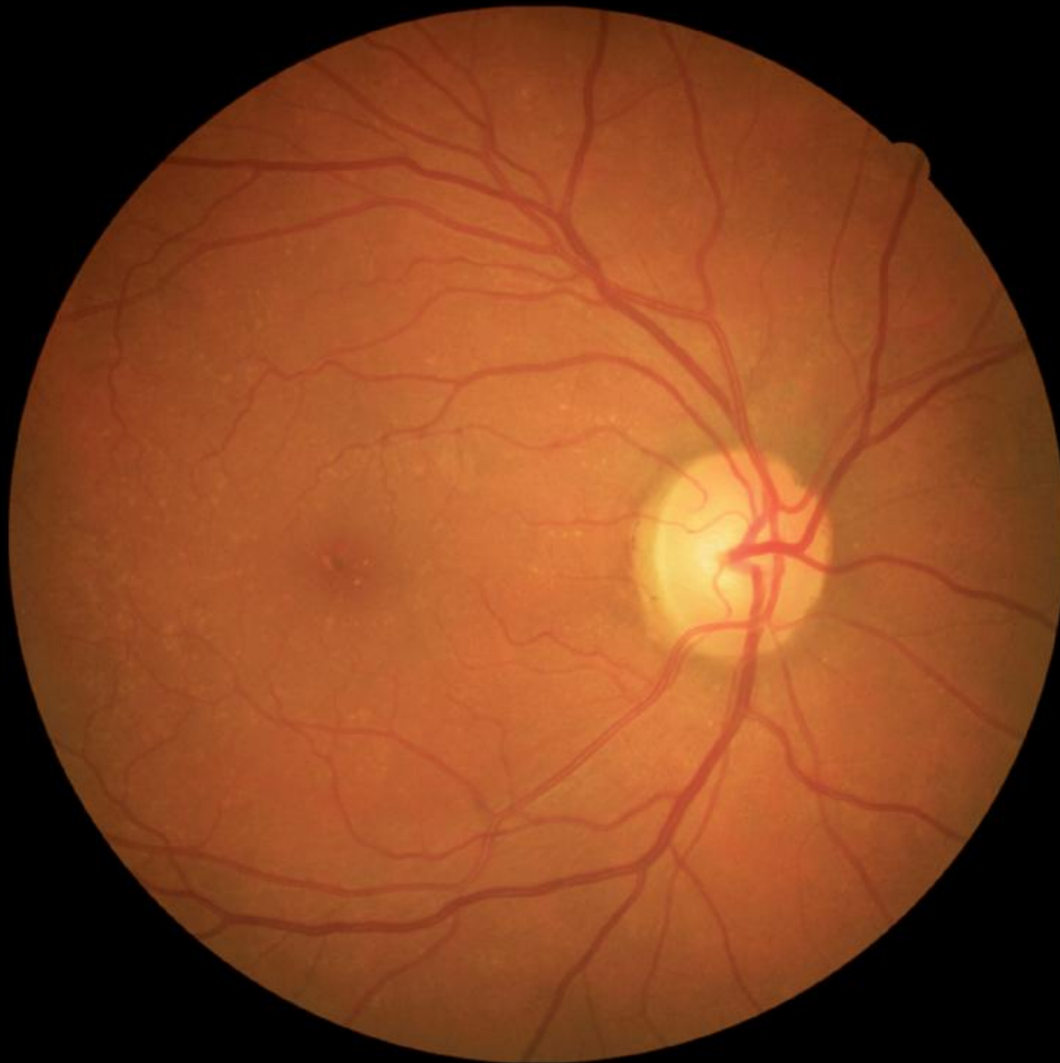
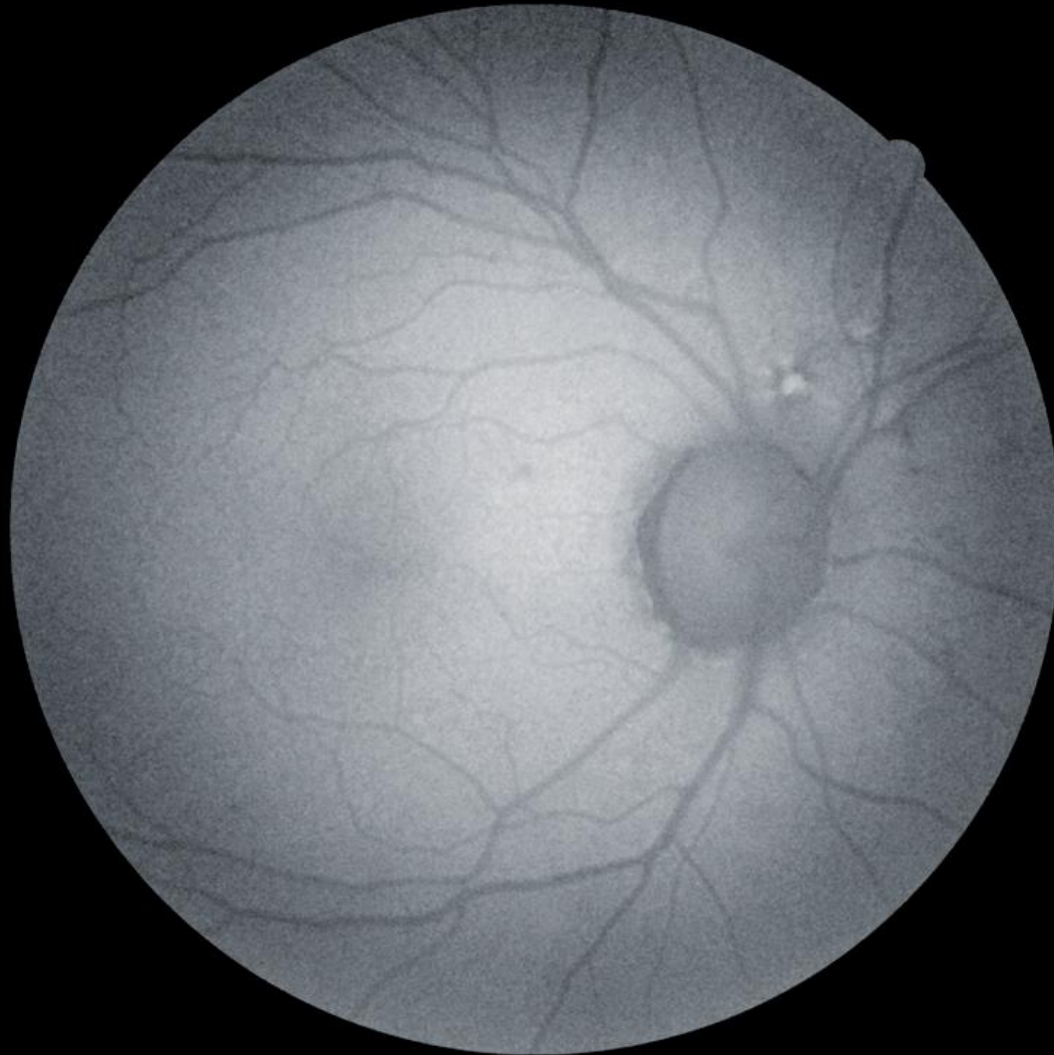
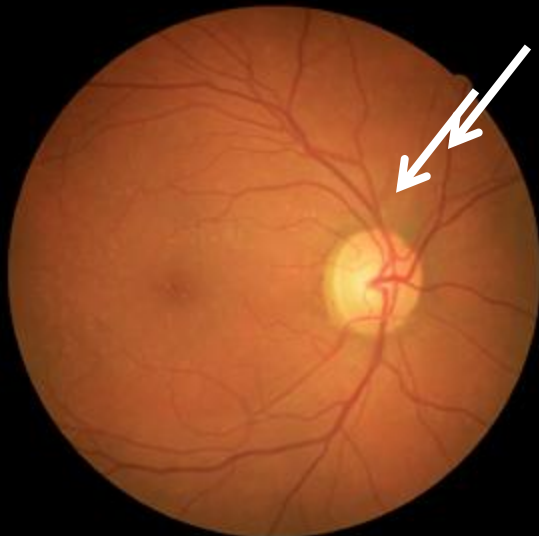
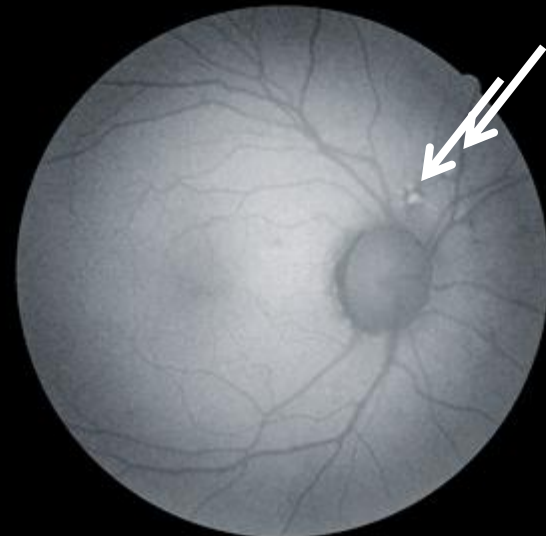
Case #2

- The colored image shows multiple hard drusen in the macula and fovea.
- The FAF shows irregular AF mainly superior to the papillae indicating ongoing RPE changes.

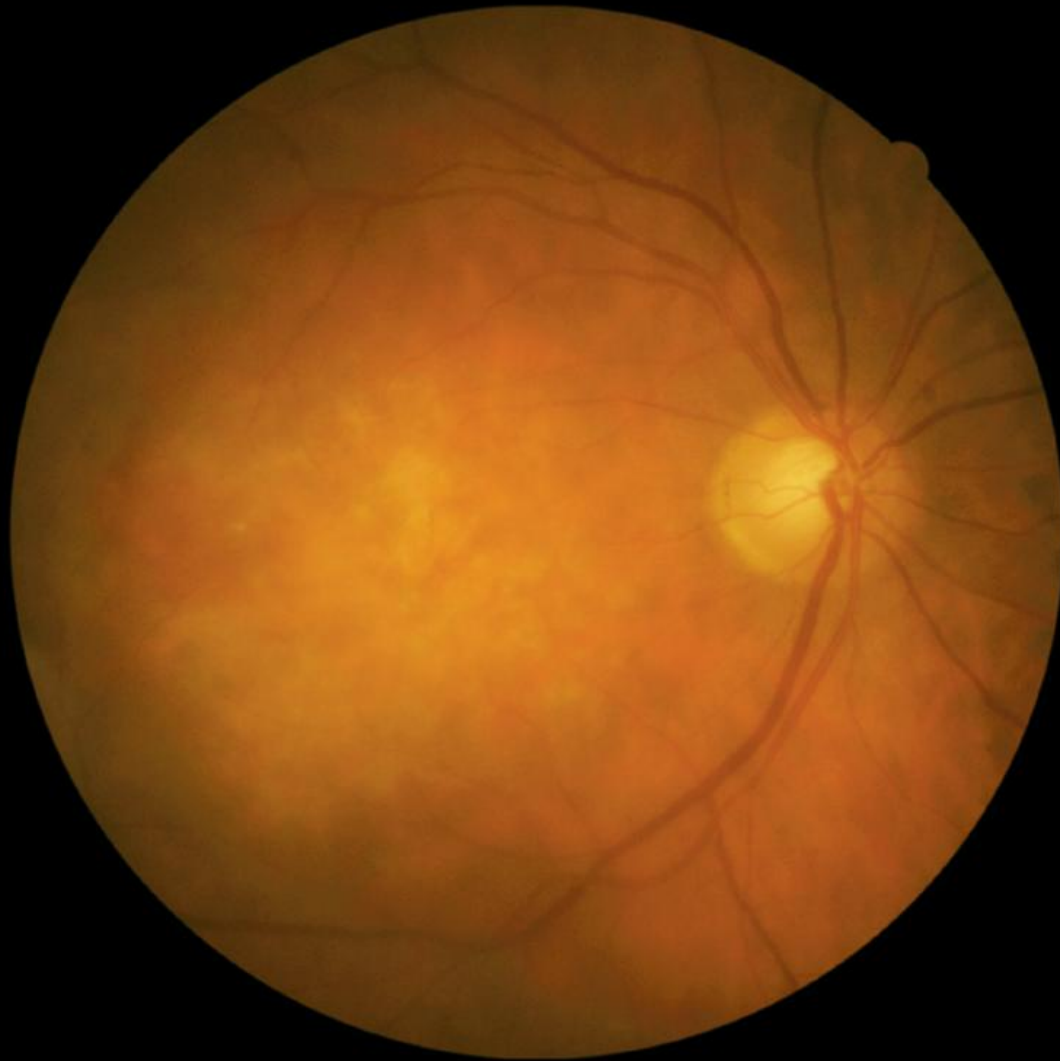
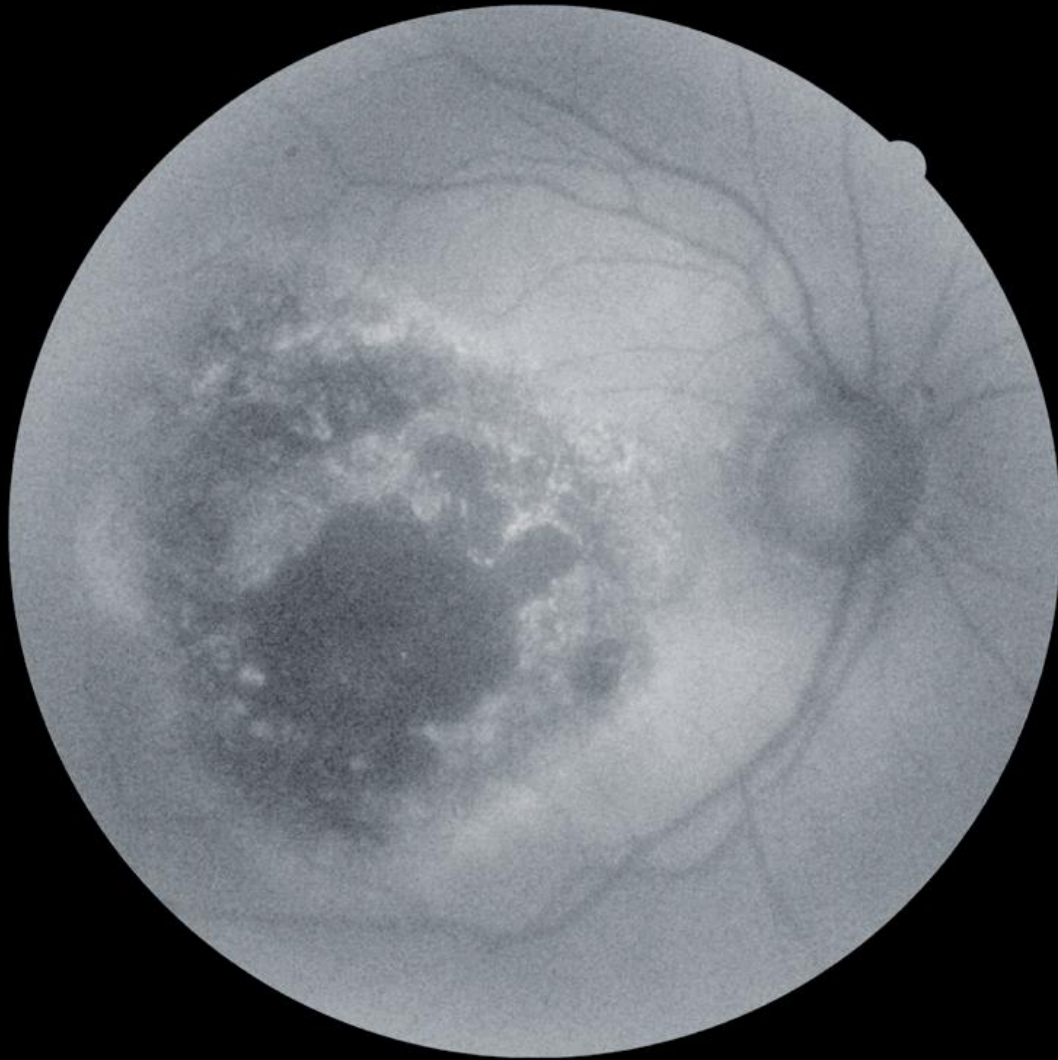
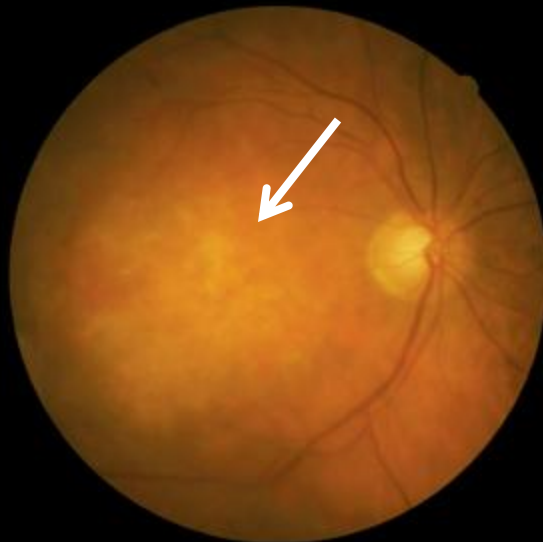
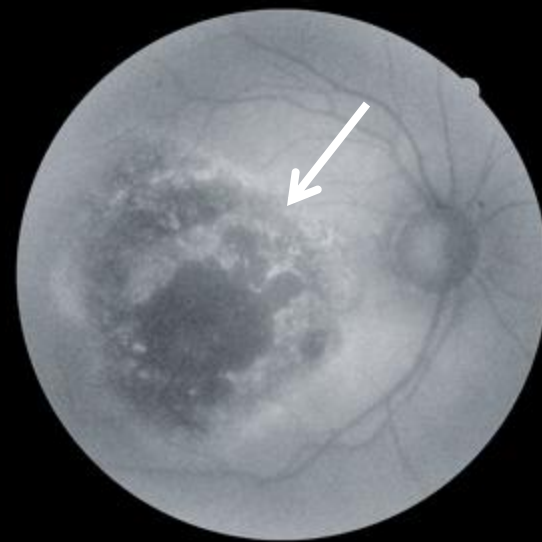
Case #3

- Patient previously treated for neovascular AMD in right eye.
- The colored image shows soft drusen and RPE changes.
- FAF image shows a lack of AF in large areas due to pigment epithelial atrophy (dark areas) and AF irregularities near the atrophic patches (bright areas).
- The FAF illustrates the severity of the changes in relation to VA.

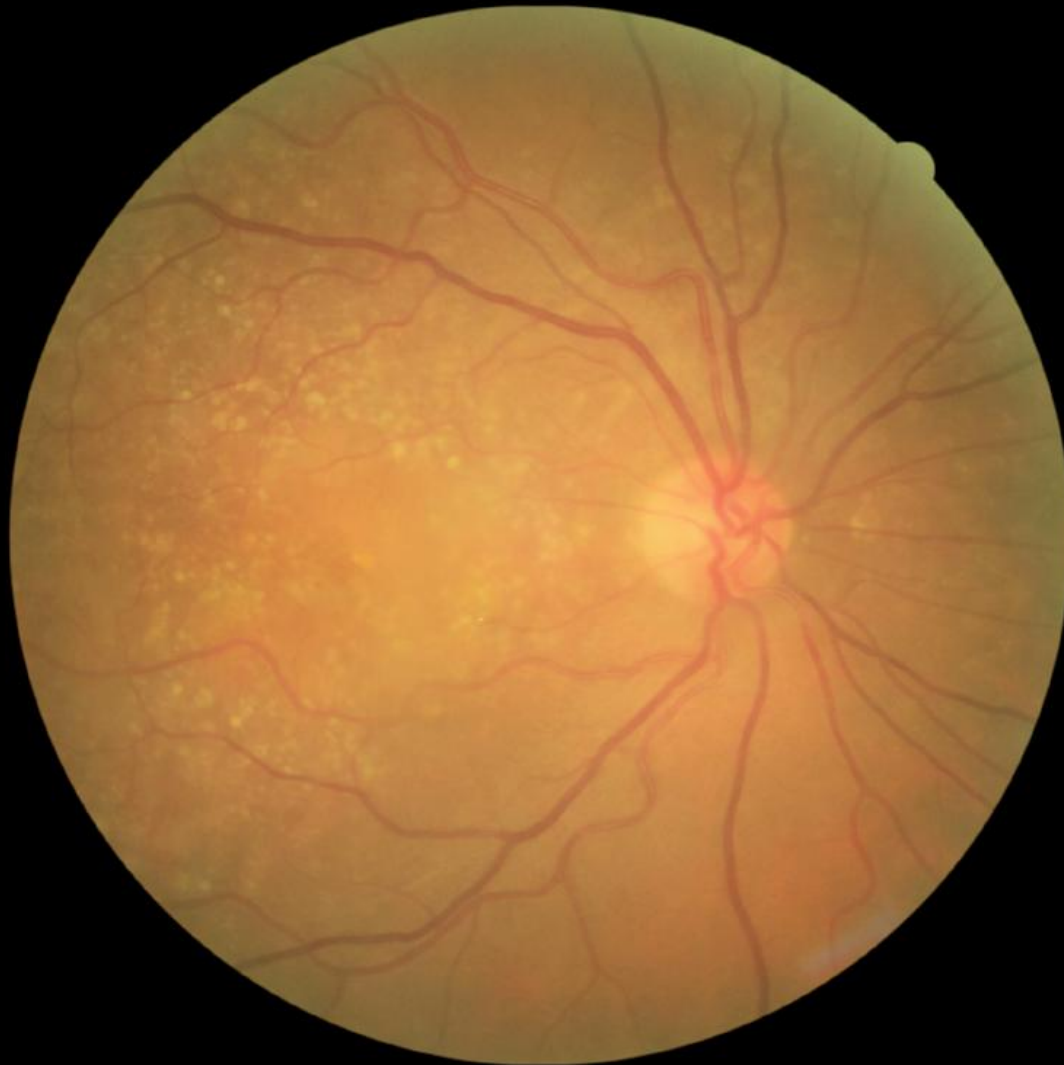
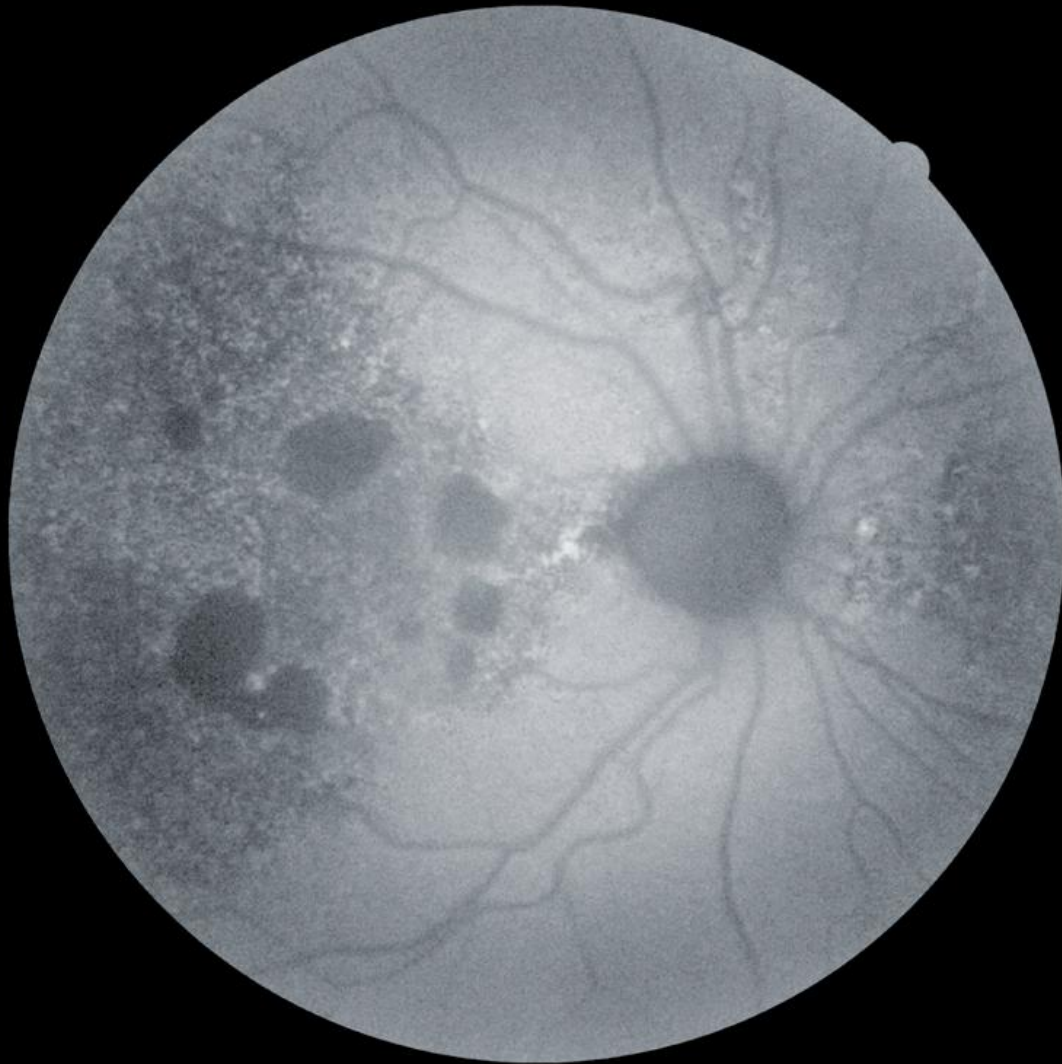
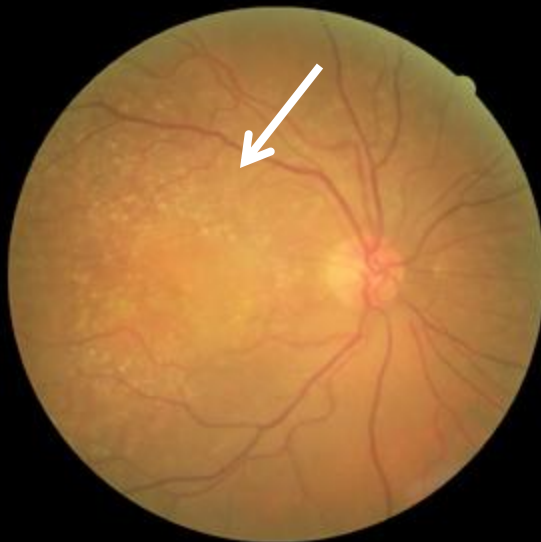
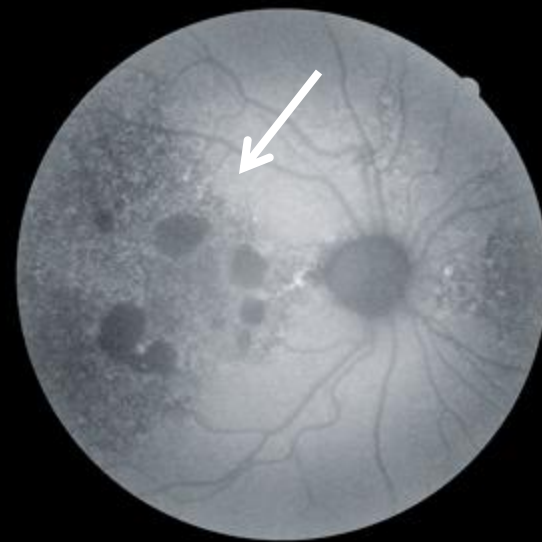
Case #4

- The colored image shows soft drusen and RPE changes.
- FAF image shows AF irregularities indicating ongoing RPE changes (bright spots) and damage (dark spots).

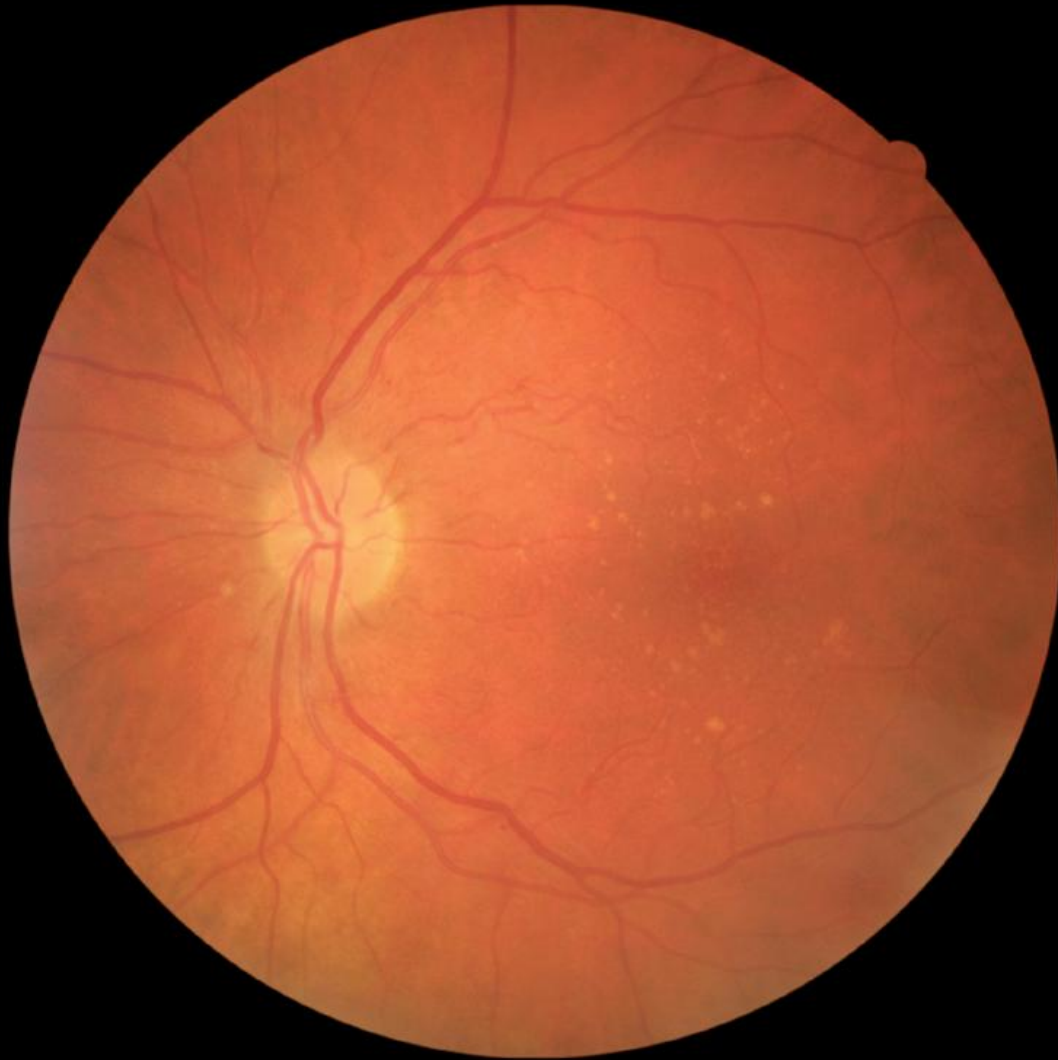
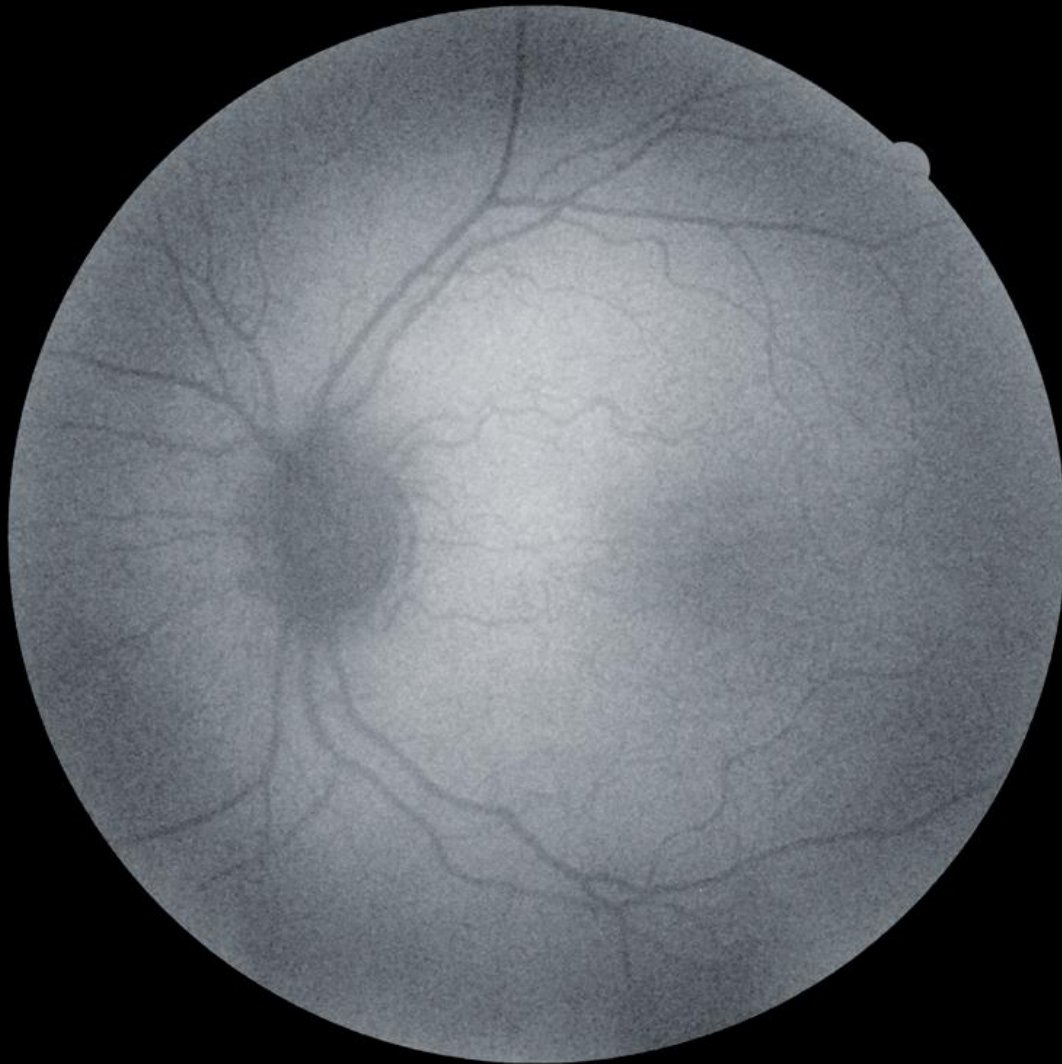
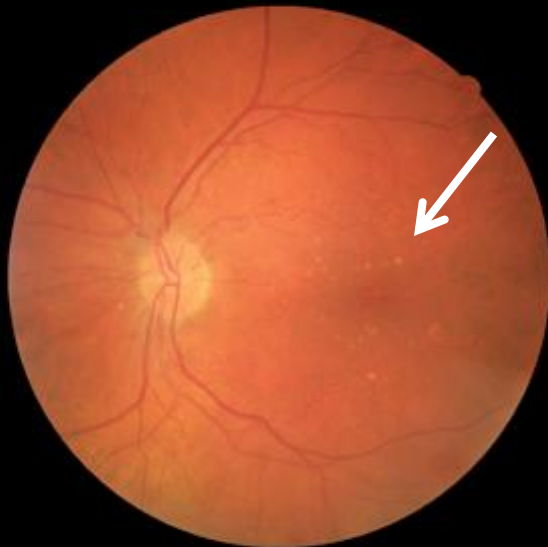
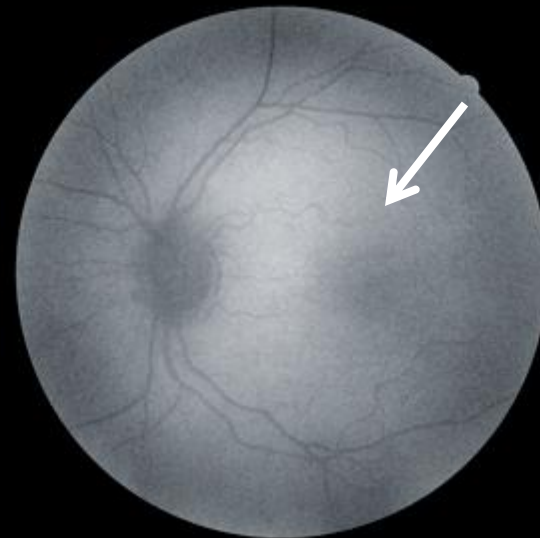
Case #5

- The colored image shows hard drusen as well as a few soft drusen in the macula. The FAF appears normal.

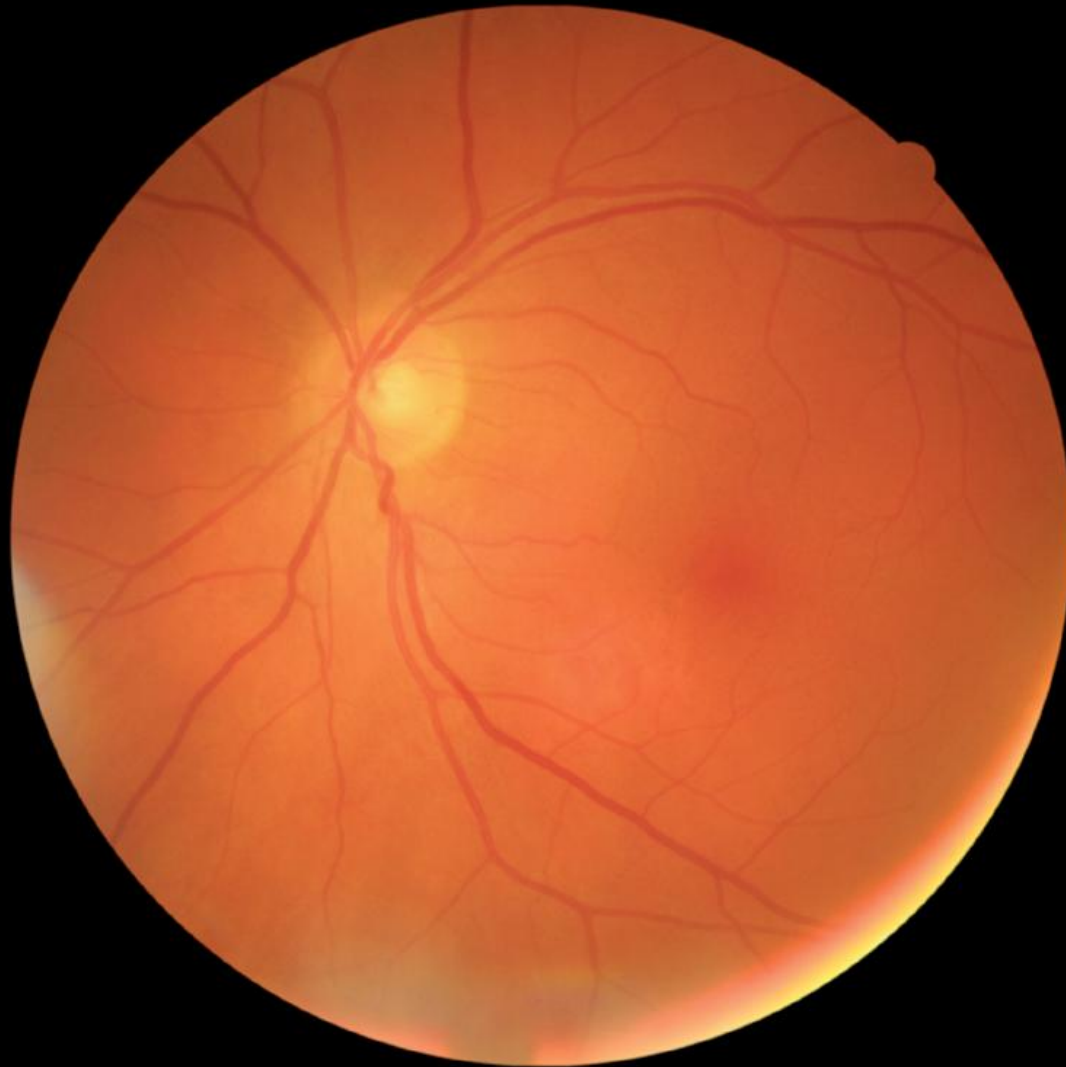
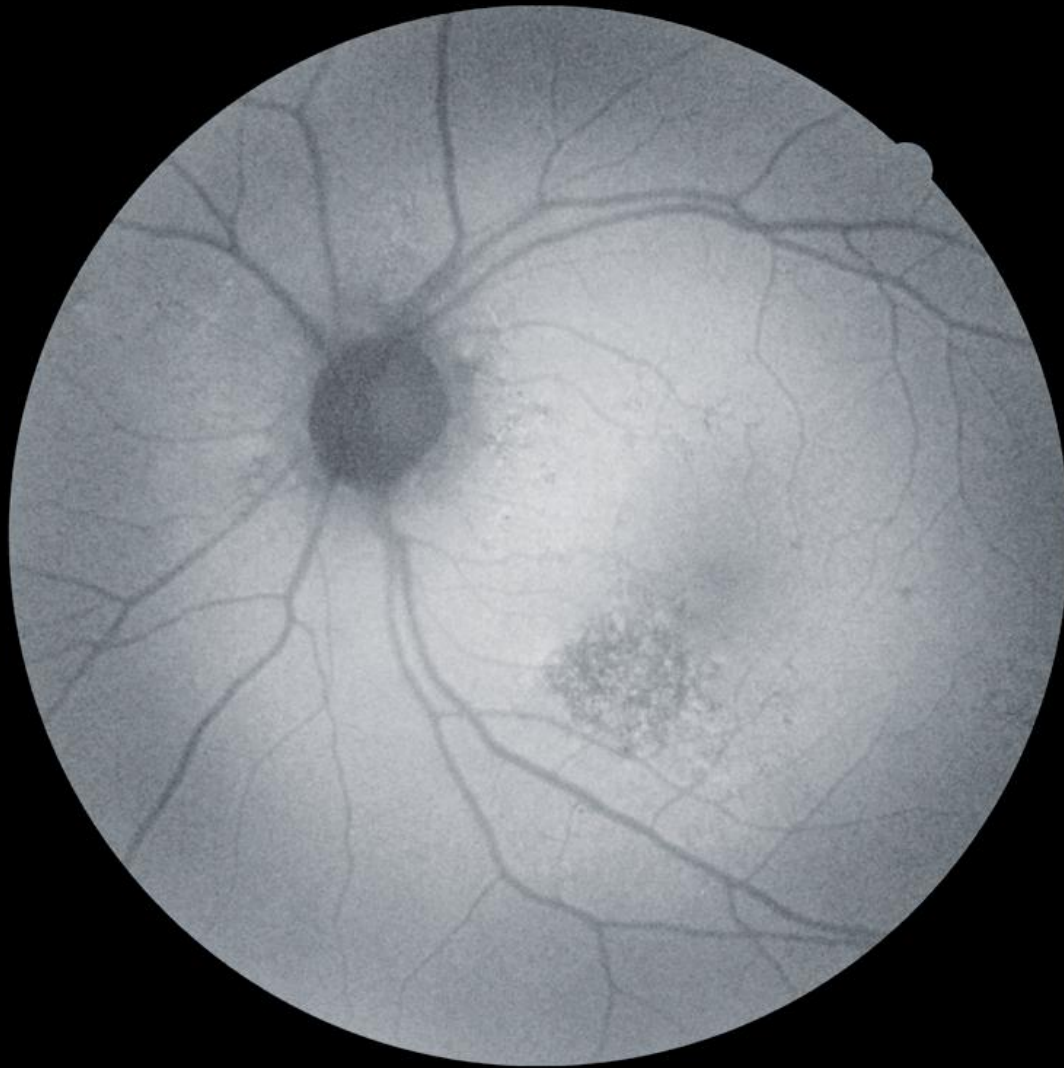
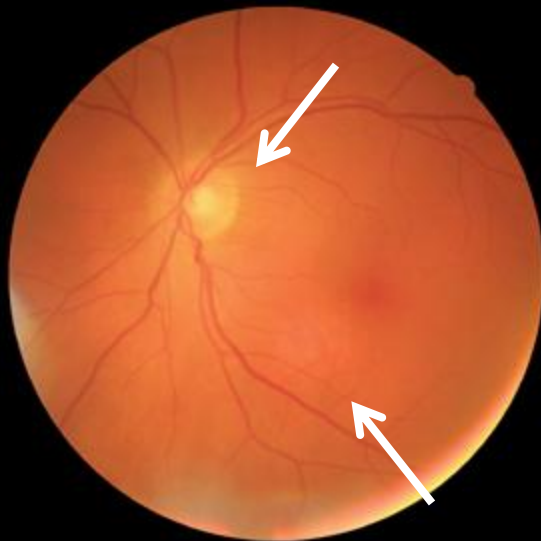
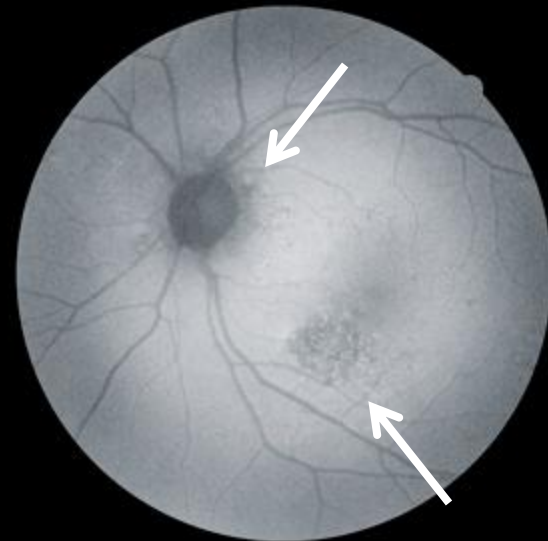
Case #6

- The colored image shows discrete macular changes with some atrophic areas.
- The FAF shows variations in AF pattern in the macula and around the papillae indicating ongoing RPE changes (bright dots) and RPE damage (dark areas).

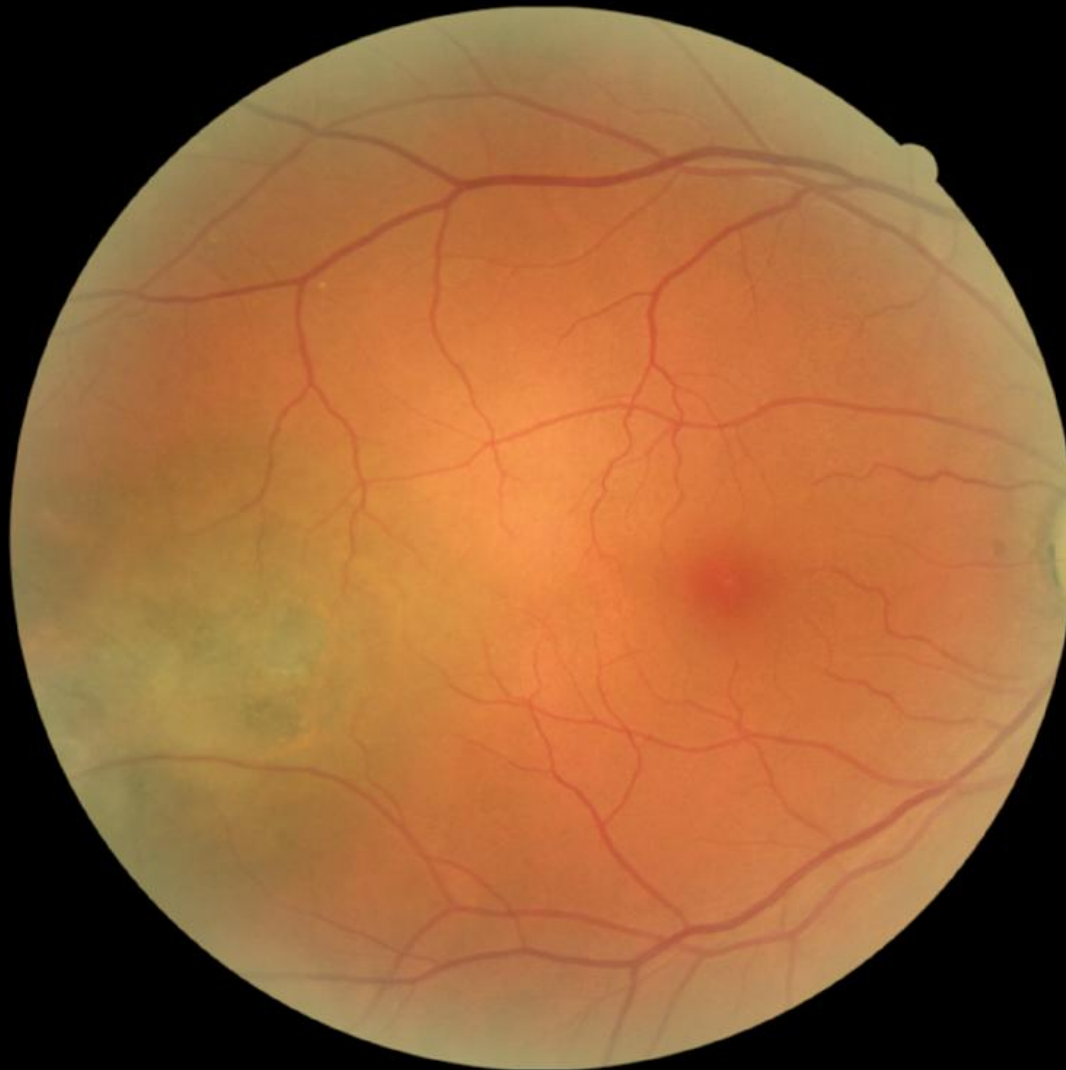
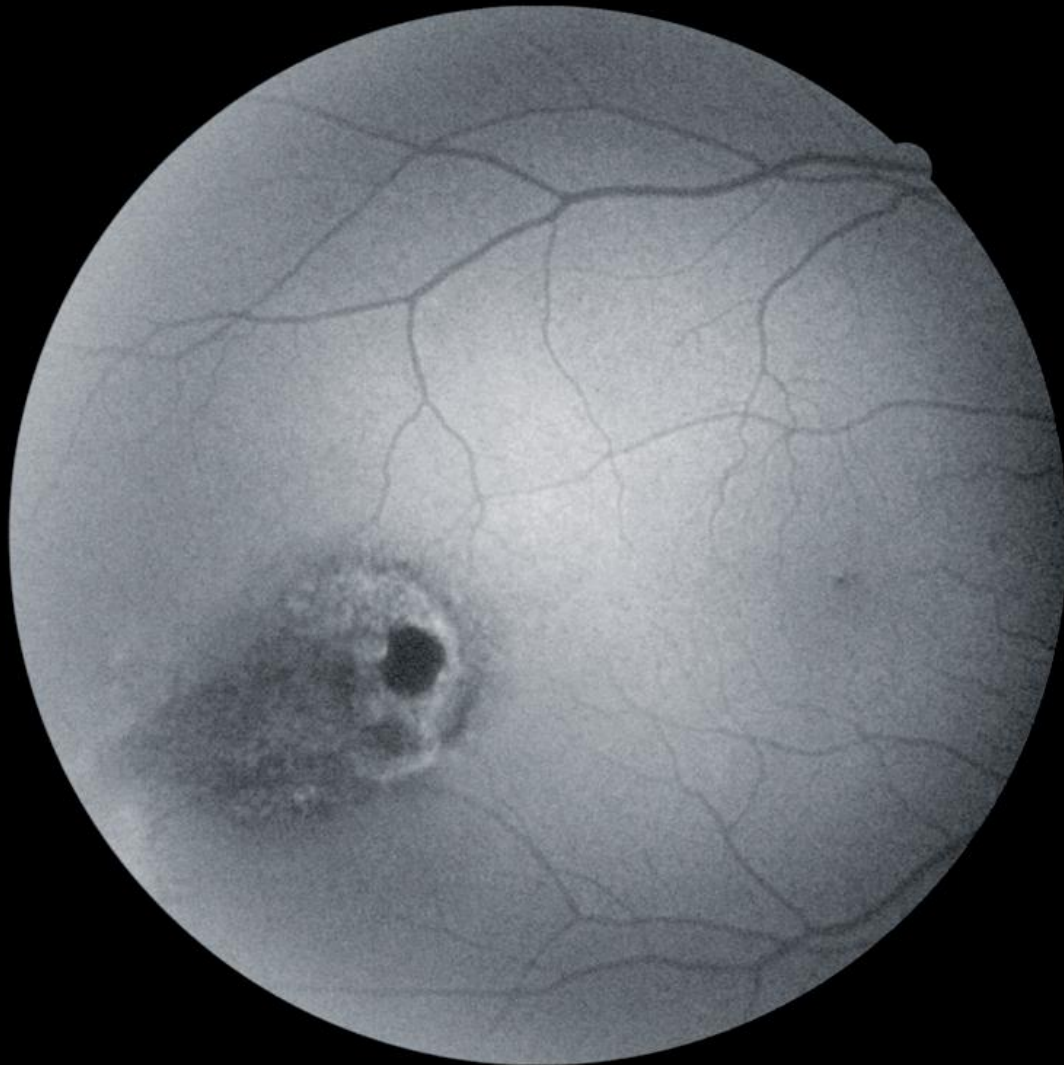
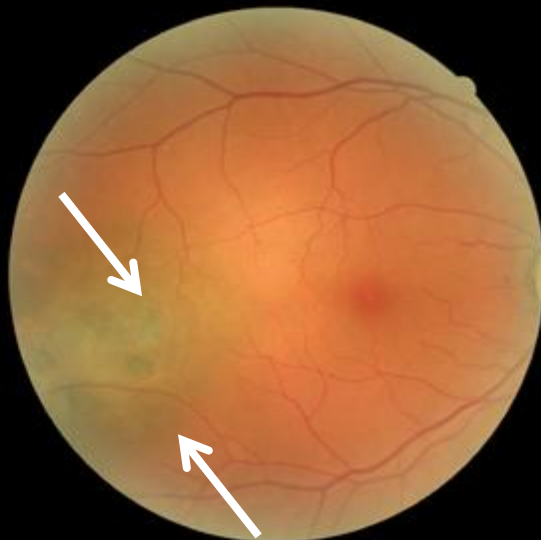
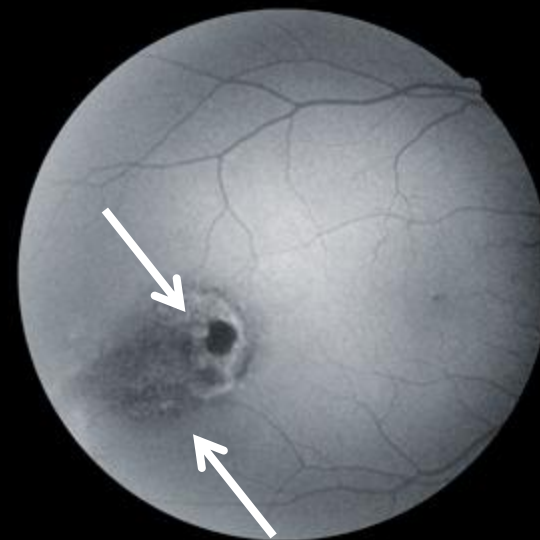
Case #7

- Choroidal malignant melanoma with overlying orange pigment.
- Corresponding FAF-picture shows areas of both hypo- and hyperfluorescence where the melanoma is located. The area of increased
- AF corresponds to the areas of orange pigment.
